GENERAL ELECTRIC COMPANY

Vallecitos Atomic Laboratory

Ventilation Exhaust Stack (A)

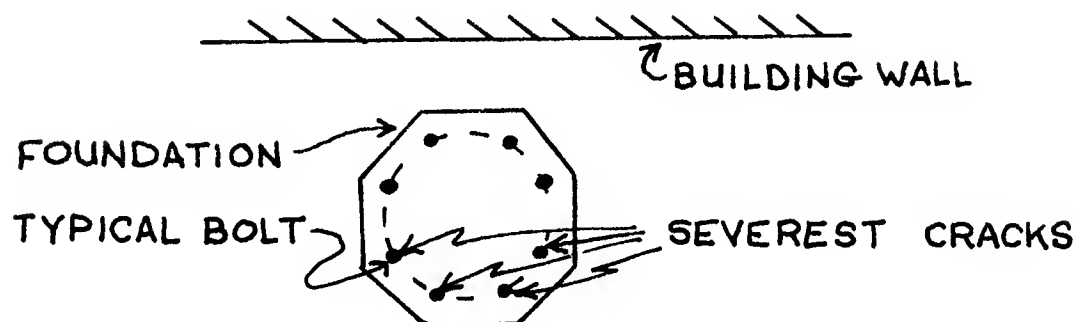
Exhibit 1, insert.

Shortly after work on the extension began in the summer of 1965, a construction engineer on the job reported to Mr. Eagan that the concrete base of the stack was cracked. There were small cracks at each anchor bolt location (Exhibit 1, insert). Each of the four severest cracks ran from an anchor bolt in a roughly vertical path down the base and appeared to continue into the ground.

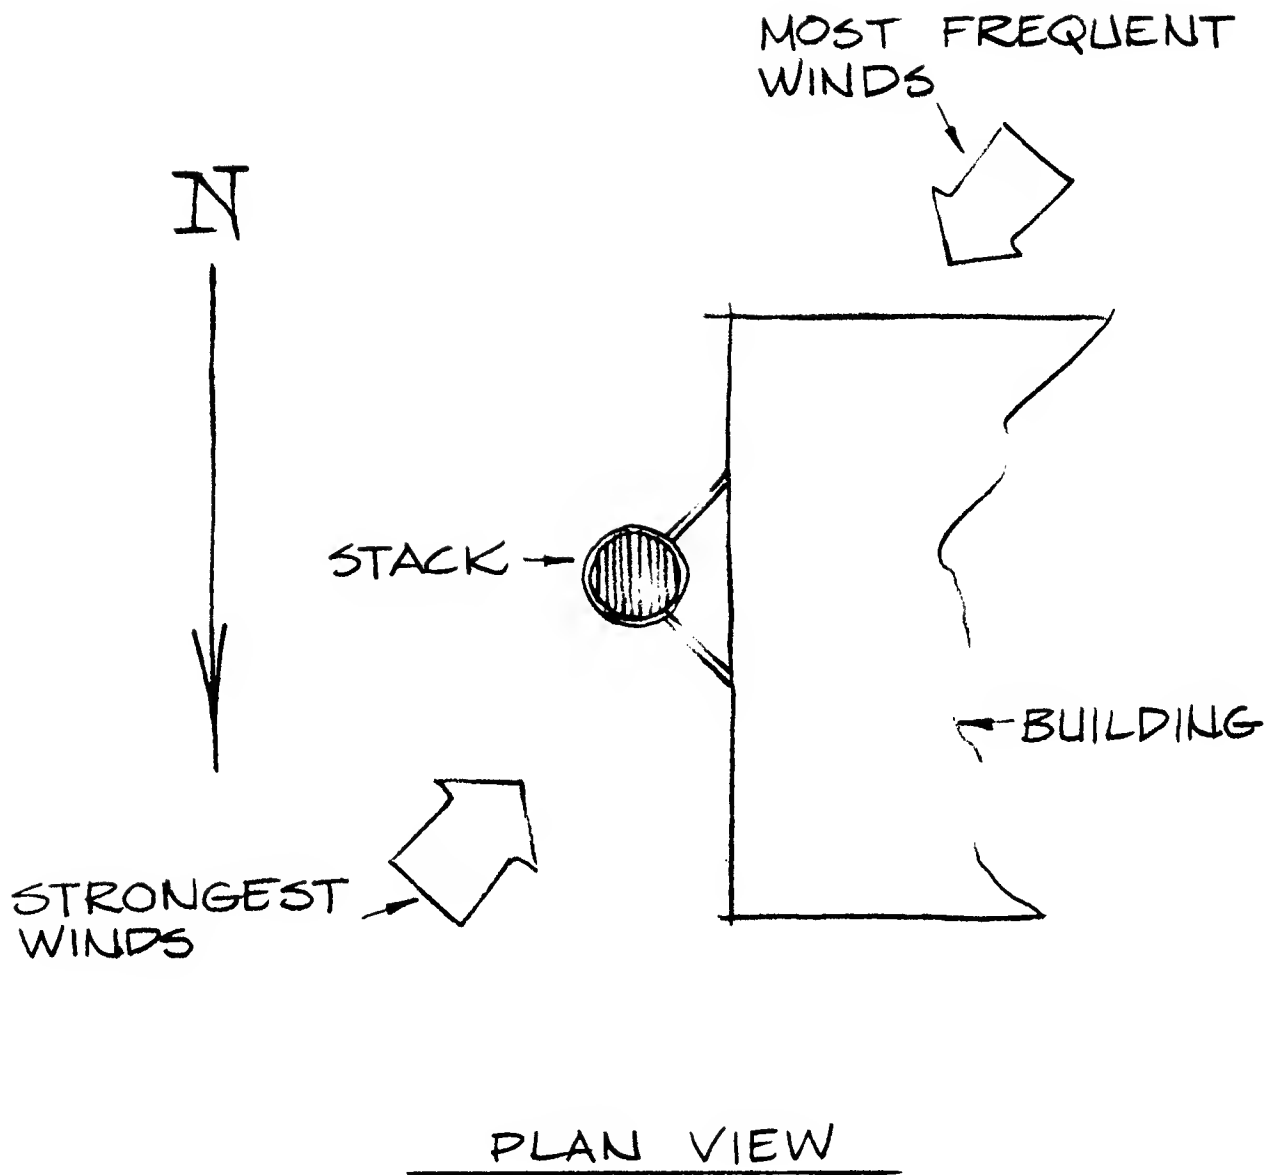
Exhibit 4.

On the basis of his theoretical calculations, he concluded that even a wind of 90 mph would not overload the stack's anchor bolts (see Exhibit 4).
